SEFA 8 CERTIFICATE OF PERFORMANCE

LABORATORY FURNITURE - SEFA 8

DESCRIPTION OF TEST CABINET

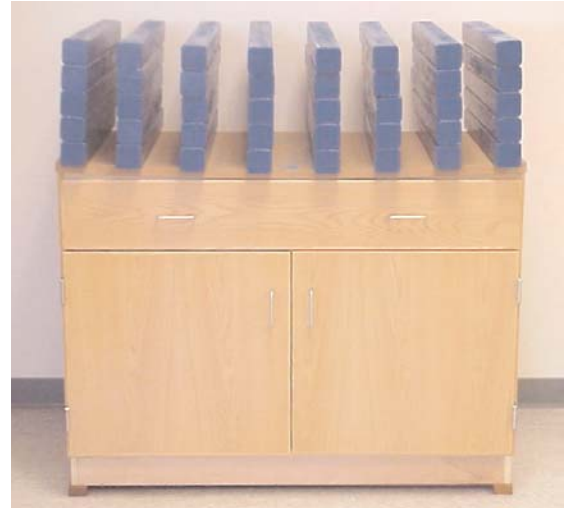
CABINET LOAD TEST

The cabinet top was loaded using 2,000 pounds of solid steel bars stacked five high, in eight equally spaced rows. After 10 minutes, the bars were removed from the cabinet.

There are no signs of permanent damage.

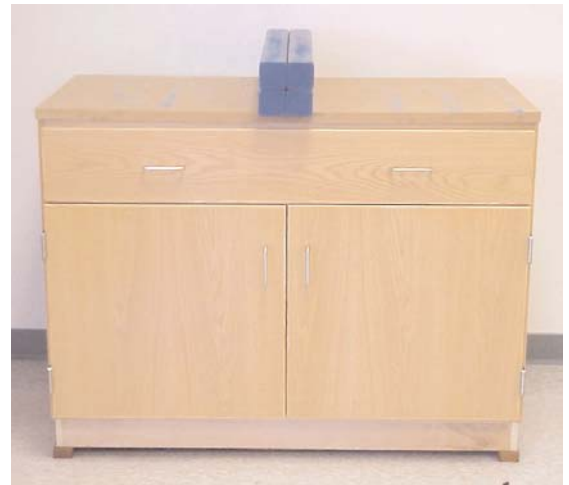
CABINET CONCENTRATED LOAD TEST

Four, 50 pound solid steel bars were placed on top of the cabinet, along the cabinet centerline. With the weight in place, the drawers and doors were operated and inspected.

Doors and drawers operated normally. There is no permanent distortion to the front rail, cabinet joinery, doors, or drawers.

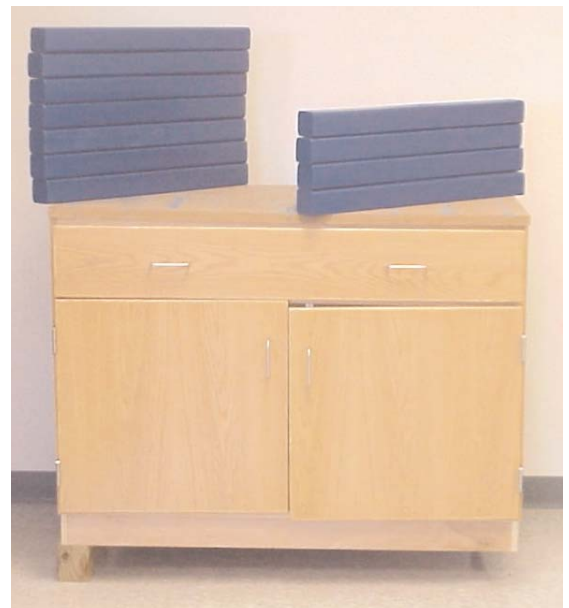
CABINET TORSION

The cabinet was supported on three, 3-1/4" x 3-1/2" x 4"H hardwood blocks, located under the two rear corners and one front corner. The cabinet was secured, diagonally from the unsupported corner with seven, 50 pound, solid steel bars to prevent overturning. Four, 50 pound, solid steel bars were placed on the unsupported corner of the cabinet and left in position for 15 minutes. The weights were then removed and the cabinet was placed on the floor in its normal, upright, position. The cabinet joinery was inspected and the cabinet was leveled and measured, diagonally, between the corners of the face and the back of the cabinet.

When returned to normal position, the operation of the cabinet was normal and there was no evidence of permanent damage. The difference between the diagonal measurements does not exceed 1/8" front or back.

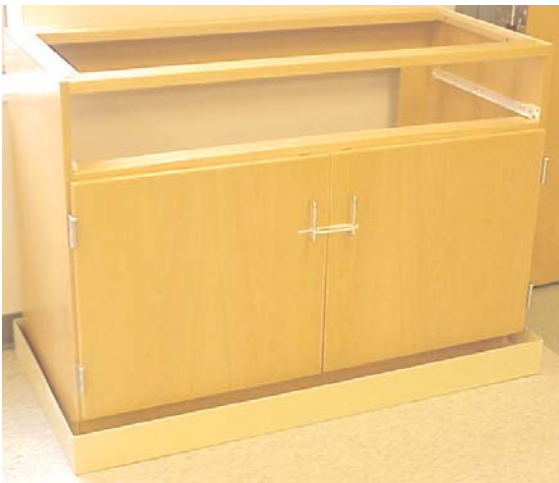
CABINET SUBMERSION TEST

The thickness of the material along the perimeter of the bottom of the cabinet was measured on 6" increments. The thickness was recorded and the arithmetic mean was calculated. The cabinet was then placed in a pan of water so that the bottom 2" of the cabinet was submerged. The cabinet remained in the water for 4 hours and then it was removed and immediately re-measured at the same locations that were measured initially. The thickness at each location was recorded and the arithmetic mean was calculated. After the cabinet had dried, it was inspected for damage.

The cabinet shows no signs of permanent deformation or deterioration and the average increase in thickness is less than four percent (3.5%).

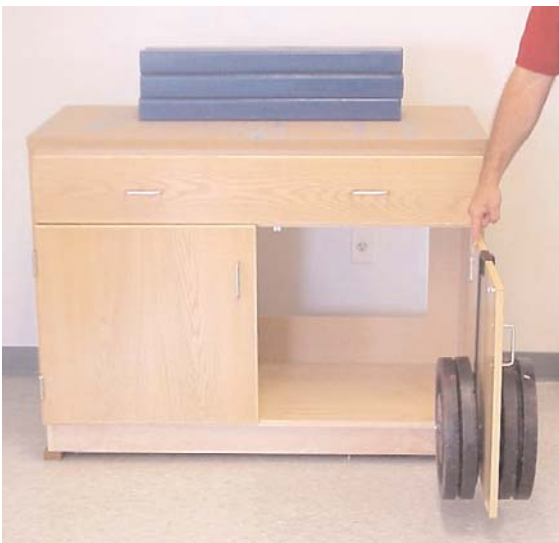
DOOR HINGE TEST

The shelf was removed and weight was placed on top of the cabinet to prevent it from overturning. A cabinet door was opened 90° and a sling with four 50 pound weights was hung over the top of the door, at a point out from the hinge centerline. The door was then slowly moved through the full cycle of the hinge (up to a 160° arc). The weight was then removed, the door was swung through its full intended range of motion, and closed.

There was no significant permanent distortion and the door operated normally after the weight was removed.

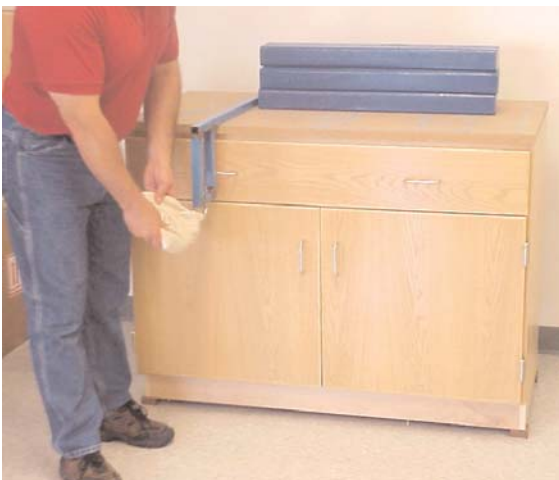
DOOR IMPACT TEST

Eight, 50 pound solid steel bars were placed on top of the cabinet to prevent overturning. A 20 pound sand bag was then suspended from a pendulum support and dropped providing an impact of 240 inch-pound at the center of a closed door.

Door and catch operated normally and show no signs of permanent damage.

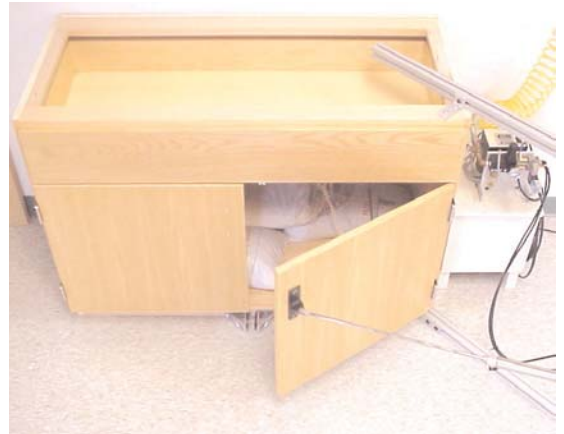
DOOR CYCLE TEST

A cycling mechanism, that swings a door through an arc of 90°, was operated for 100,000 cycles.

The door operated for the full 100,000 cycles without deterioration that significantly affected the function of the door. After completion of the test, the door operates freely and without binding.

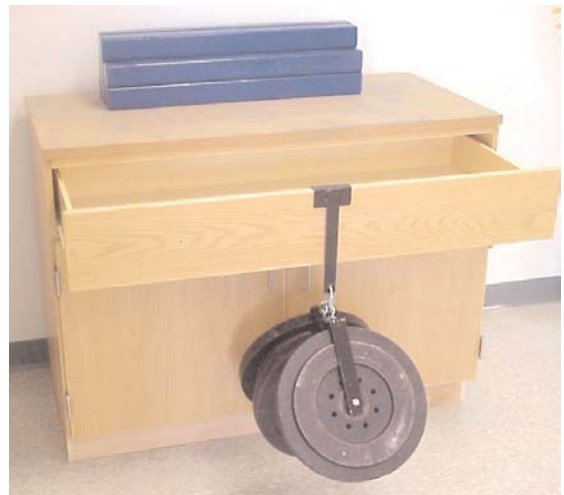
DRAWER STATIC LOAD TEST

Eight, 50 pound solid steel bars were placed on top of the cabinet to prevent overturning. A drawer was opened to 13" of travel and 150 pounds was hung from the drawer head, at the centerline of the drawer, for 5 minutes. The weight was then removed and the drawer was operated through the full cycle.

There was no interference with the normal operation of the drawer.

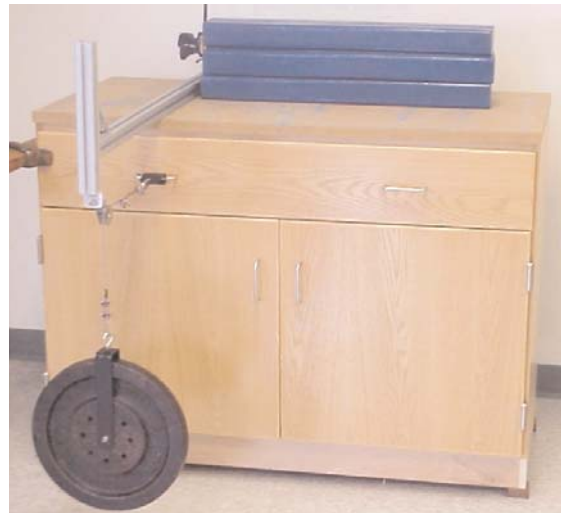
DRAWER & DOOR PULL TEST

The pulls were installed in accordance with Diversified Woodcrafts practice using specified attaching hardware and method. A drawer and a door were blocked closed and a cable, pulley, and weight assembly was used to apply a force of 50 pounds perpendicular to each pull. Similar set-up was then used to hang a 50 pound weight from each pull.

Pulls resisted the force and supported the weight and there is no evidence of permanent distortion.

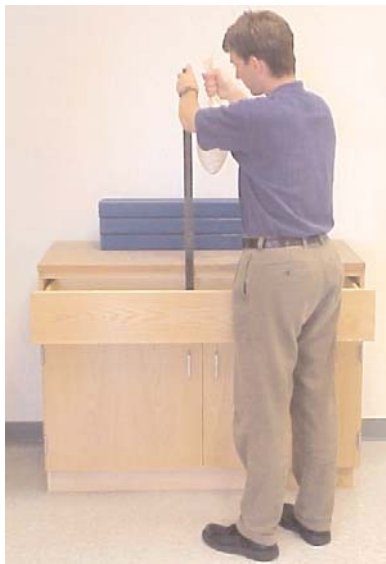
DRAWER IMPACT TEST

A drawer was opened to 13" of travel and then a 10 pound sand bag was dropped, from a height of 24", into the bottom of the drawer, at the centerline of the width of the drawer and 6" back from the inside face of the drawer.

The drawer was operated through a full cycle and it operated normally. There was no visible deformation of the drawer.

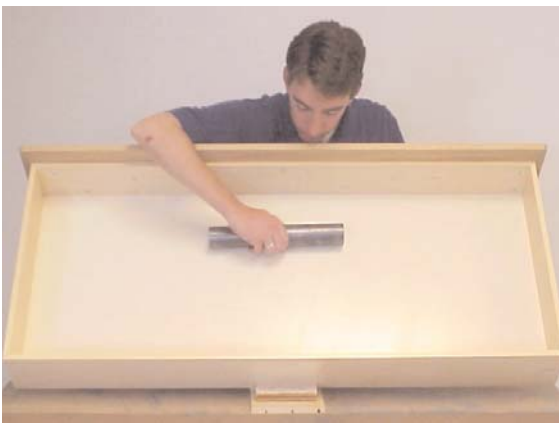
DRAWER INTERNAL ROLLING IMPACT

The drawer was positioned on a table at a 45° angle and a 2" diameter by 12" long steel rod, that weighs approximately 10 pounds, was positioned 13" from the target impact area such that the rod rolled freely to impact the back of the drawer. The back was subjected to three impacts and then the drawer was reversed and the front was subject to three additional impacts.

There are no visible signs of permanent damage. All joinery is intact and the drawer operated normally when returned to the unit.

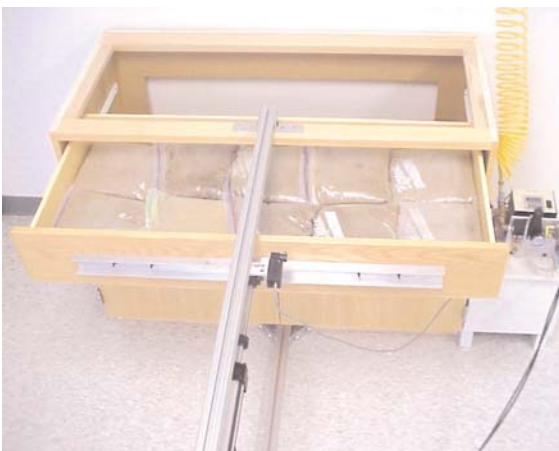
DRAWER CYCLE TEST

A static load of 100 pounds (using ten 10 pound sand bags) was uniformly distributed in a drawer and the force required to activate the drawer was measured. The drawer was then opened from a closed position to a position within 1/4" of full extension and then closed. The procedure was repeated 50,000 times at a rate that did not exceed 10 cycles per minute.

After the 50,000 cycles were completed, the drawer operated freely with no evidence of dragging, rubbing, or binding. The force required to open and close the loaded drawer increased by 7.1% which is less than the allowable maximum (20%). The force required to open and close the loaded drawer was less than 8 pounds.

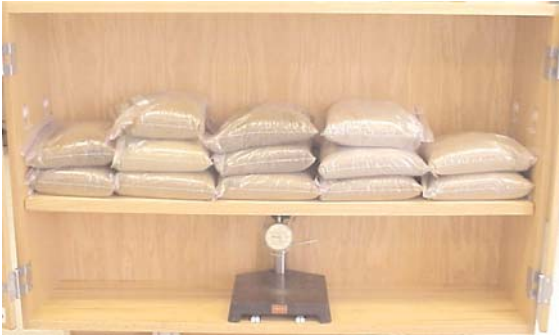
SHELVING

The shelf was mounted in the manner in which it was designed and a dial indicator was positioned under the center of the shelf and adjusted to zero. Thirteen 10 pound sand bags were uniformly distributed on the shelf to obtain a loading of 40 pounds per square foot of shelf area and the deflection was recorded. The weight was then removed from the shelf.

The deflection of the shelf under load - 0.245" which is less than the allowable maximum of 0.25". There was no significant permanent distortion of the shelf.

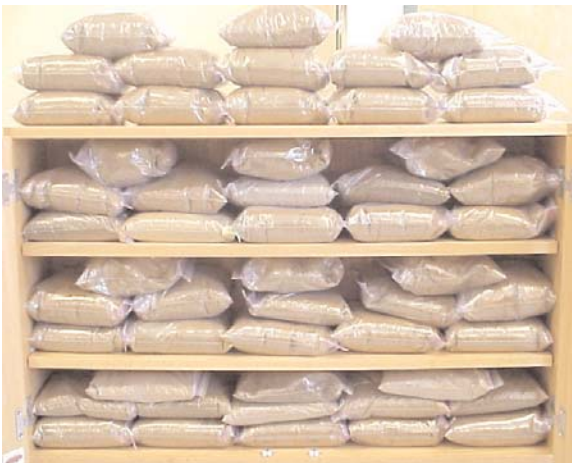
WALL CABINET LOAD TEST

130 pounds of sand bags, 40 pounds per square foot, were used to load the cabinet bottom, the cabinet top and shelves. With the weight in place the doors were operated through their full travel to verify normal operation. The weight was then removed and the doors were again operated through their full travel to verify normal operation.

Doors opened and closed normally with and without the weight in place. There is no significant permanent deflection or damage to cabinet, cabinet back, cabinet top, cabinet bottom or shelf.
